# Vehicle Surge Between 40 and 50 mph

**Section** Automatic Transmission/Transaxle

YEAR(S)	MODEL(S)	ADDITIONAL INFORMATION
2016 - 2017	Tacoma	WMI(s): 3TM, 5YF VDS(s): AZ5CN, BZ5DN, CZ5AN, DZ5BN, EZ5CN, GZ5AN, HZ5BN, RZ5CN, SZ5AN Engine(s): 2GR Transmission(s): 6AT

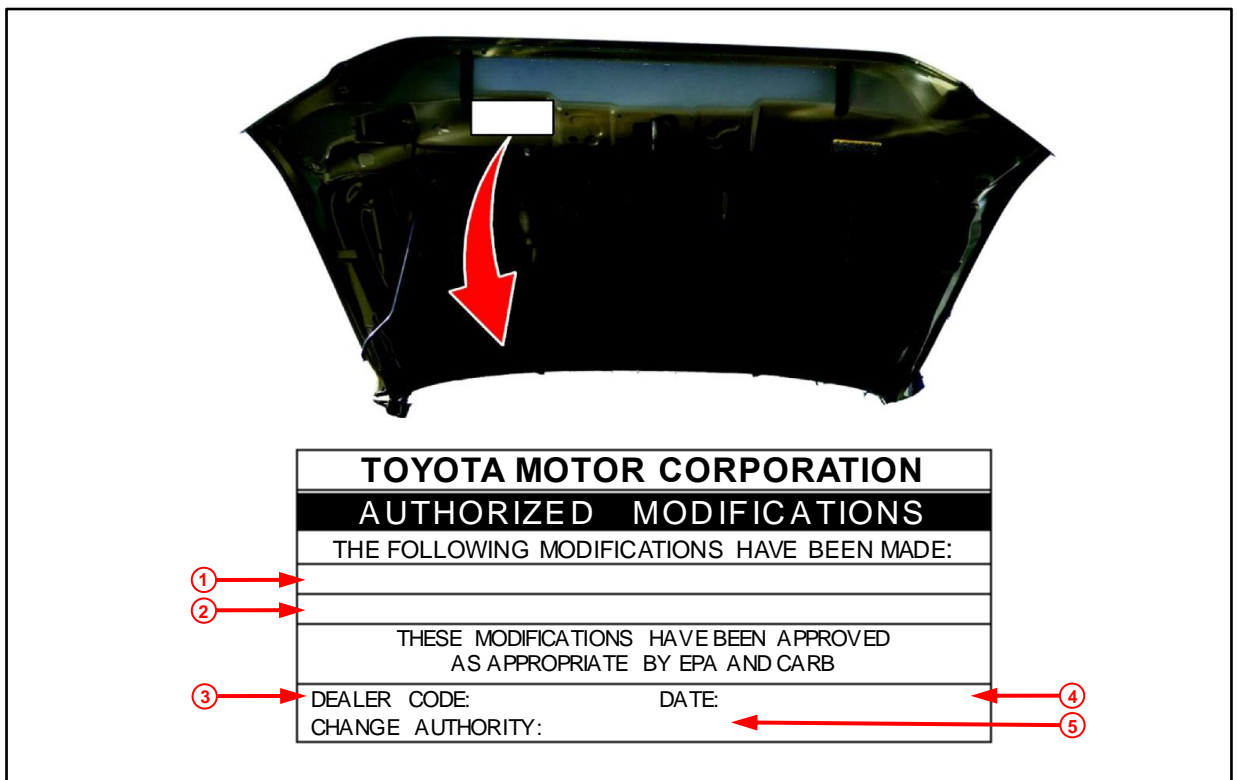
**Figure 1. Location of Authorized Modifications Label for 2016 – 2017 Tacoma**

<b>1</b>	<b>Replacement ECM (PCM) Part Number (e.g., 89661-04K54)</b>
<b>2</b>	<b>New Calibration ID (e.g., 8966304B0400)</b>
<b>3</b>	<b>Dealer Code</b>

<b>4</b>	<b>Date Completed</b>
<b>5</b>	<b>This SB Number</b>

2. Check for the Authorized Modifications Label affixed to the vehicle in the location shown below. Confirm if the ECM (PCM) calibration has been updated.  
Is the calibration ID listed the latest ECM (PCM) calibration?
  - **YES** — This bulletin does NOT apply. Continue diagnosis using the applicable Repair Manual.
  - **NO** — Continue to step 3.

B. Install the Authorized Modifications Label on the vehicle at the location shown in Figure 1. The Authorized Modifications Label is available through the MDC, P/N 00451-00001-LBL.
