Instrument Panel Trim Reflection

Service Category Vehicle Interior

Section Interior Panels/Trim

YEAR(S)	MODEL(S)	ADDITIONAL INFORMATION
2018 - 2019	Camry, Camry HV

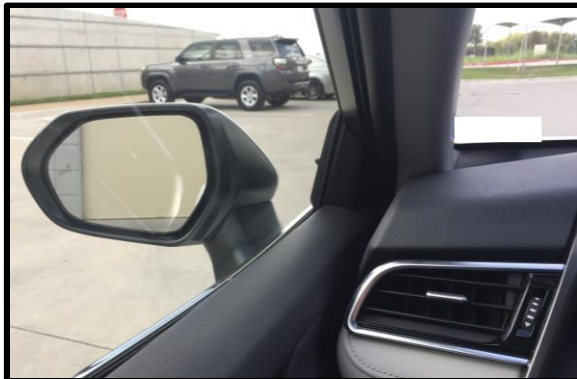
Figure 1. Brushed Aluminum Trim

Some 2018 – 2019 model year Camry and Camry Hybrid vehicles with brushed aluminum or gray metallic trim may exhibit a condition where the instrument panel LH and RH outside register assemblies reflect upon the side window glass. Alternative outside register assemblies with a gloss black finish have been developed to reduce this condition. Follow the Repair Procedure in this bulletin to reduce this condition.
