Rear View Mirror Detached From Windshield Glass

Service Category Vehicle Interior

Section Mirror (int)

Some 2018 model year C-HR vehicles may exhibit a condition where the rear view mirror button mount becomes detached from the windshield glass. This condition may occur during high temperatures when the vehicle is parked. Follow the Repair Procedure in this bulletin to address this condition.

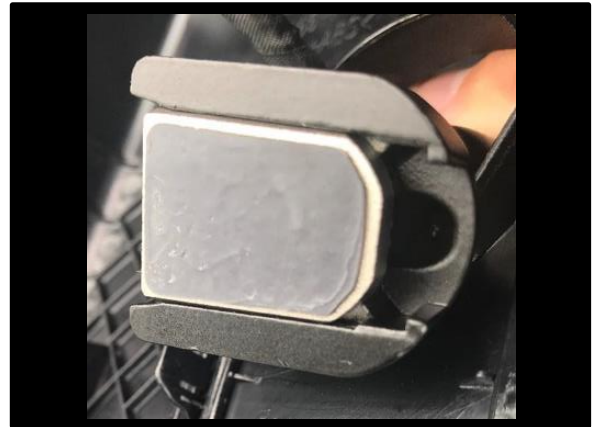
Figure 1. Rear View Mirror Button Without Glass Remnants

1. Confirm the condition exists.
 - A. Are glass remnants present on the rear view mirror button?
 - **YES** — This bulletin does NOT apply. Continue diagnosis using the applicable Repair Manual.
 - **NO** — Continue to substep B.

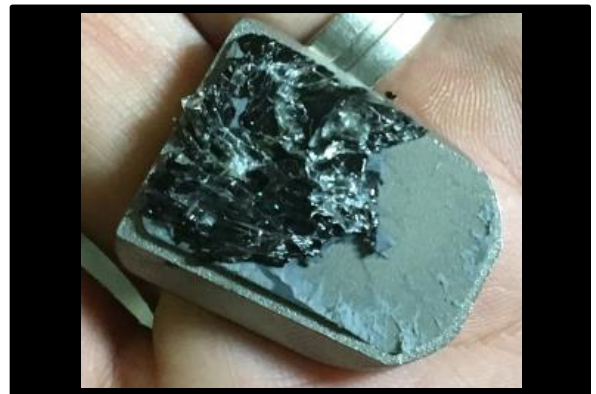
Figure 2. Rear View Mirror Button With Glass
