Spot Corrosion on B-Pillar and/or C-Pillar

Service Category Vehicle Exterior

Section Paint/Coatings

YEAR(S)	MODEL(S)	ADDITIONAL INFORMATION
2012 - 2015	Tacoma	WMI(s): 3TM, 5TF

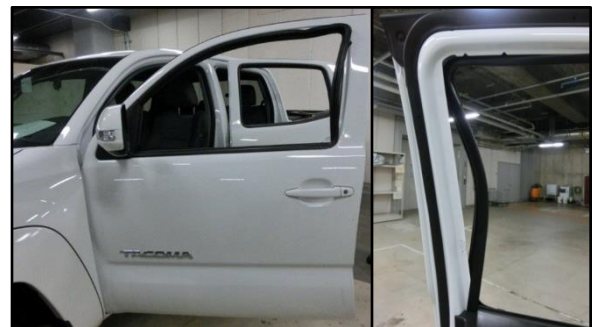
Figure 1.

- Inspect the vehicle for rust spots.
 Are ANY rust spots present on the B- or C-pillar areas?
 - YES** — Sublet to a body shop for repair, then continue to step 2.
 - NO** — This bulletin does NOT apply. Continue diagnosis using the applicable Repair Manual.
- Open the window and partially remove the door glass run as shown.
- Clean the surface with mild soap and water to remove ANY dirt and debris, then wipe dry.

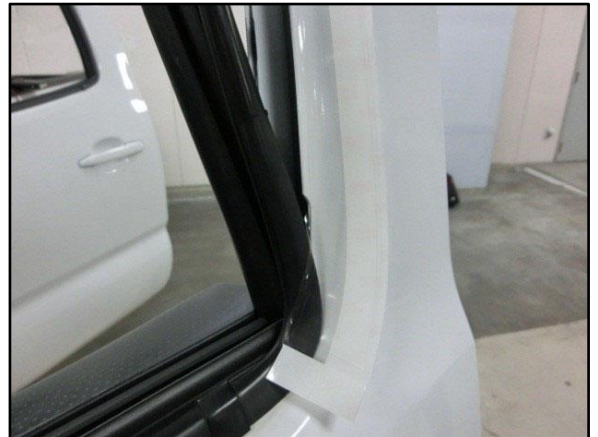
Figure 4.

7. Attach the front half of the paint protective film to the door. Align the position markers on the paint protective film with the position markers on the door as shown in step 4.

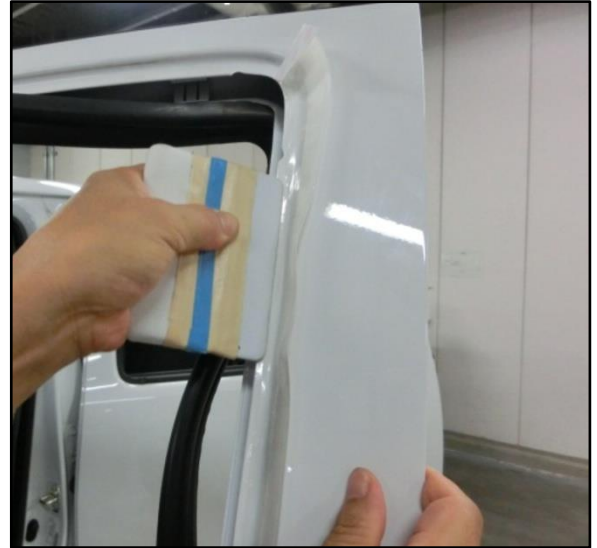
Figure 5.

8. Remove ALL water and air bubbles trapped under the paint protective film using a plastic spatula or similar tool.

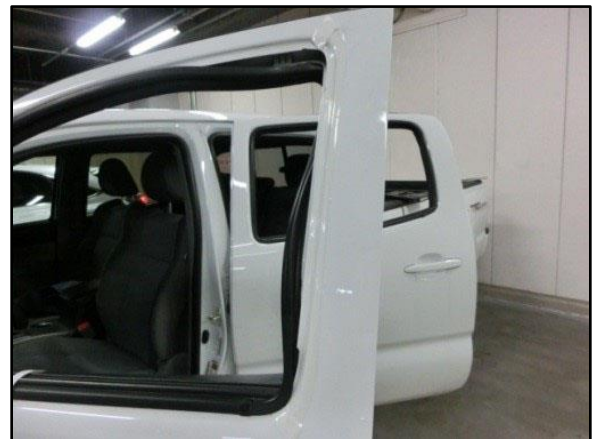
Figure 6.

9. Remove the remaining backing paper.
10. Apply water to the newly exposed paint protective film to make sure that the film can be adjusted during installation.
11. Attach the remaining paint protective film to the door. Remove ALL water and air bubbles by using a plastic spatula or a similar tool.

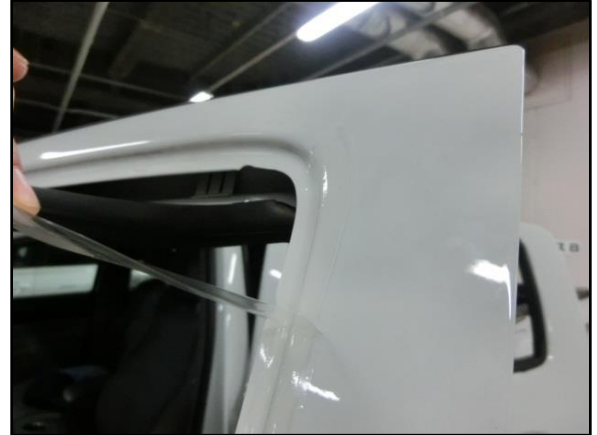
Figure 7.

12. Remove the backing film from the top surface of the paint protective film.
