# Rear Suspension Toe Adjustment Out of Specification after SR CSJ

YEAR(S)	MODEL(S)	ADDITIONAL INFORMATION
2006 – 2011	RAV4

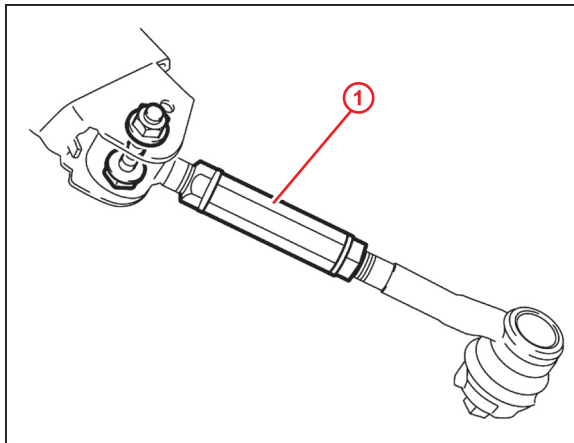
**Figure 1. Adjusting Tube Design**

<b>1</b>	<b>Adjusting Tube</b>
----------	-----------------------

- If the design is the Adjusting Tube style (Figure 1), proceed with this bulletin. Go to step 2.
- If the design is the Adjusting Cam style (Figure 2), this bulletin does NOT apply. Continue diagnosis using the applicable Repair Manual.

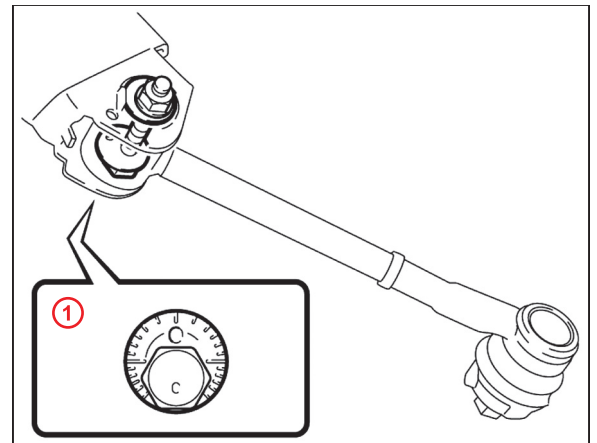
**Figure 2. Adjusting Cam Design**

<b>1</b>	<b>Adjusting Cam</b>
----------	----------------------

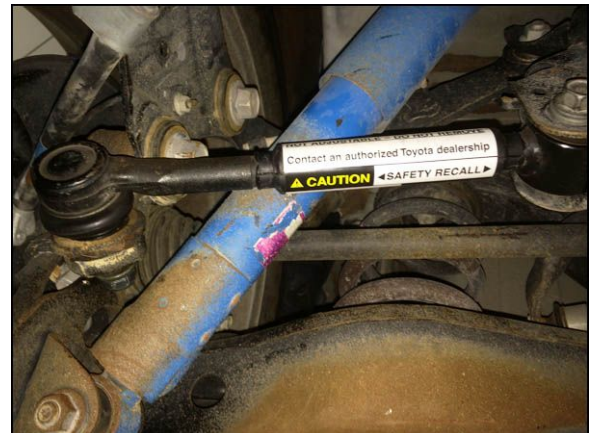
**Figure 3. Campaign CSJ Completed: Epoxy and Warning Label Applied**

Have the epoxy and warning label been applied as shown in Figure 3?

- **YES** — Continue to step 3.
- **NO** — Complete campaign CSJ.

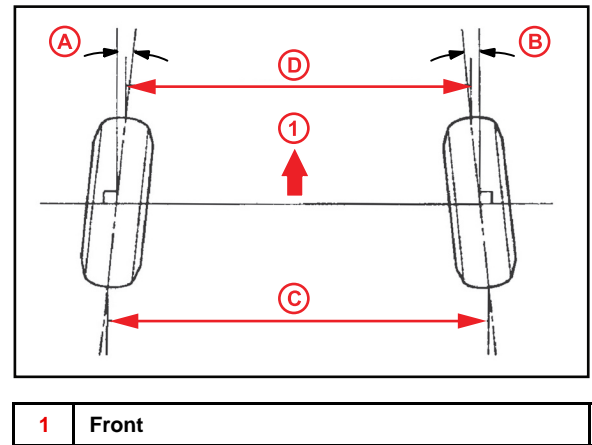
Figure 4.

STANDARD TOE-IN (UNLOADED VEHICLE)	
TIRE SIZE	FRONT A + B REAR C - D
215/70R16 225/65R17 235/55R18	A + B: 0°10' +/- 0°05' (0.17° +/- 0.09°)  C - D: 2.0 +/- 1.0 mm (0.08 +/- 0.04 in.)

- If the rear toe alignment is out of specification on either side, inspect the rear suspension for damage or bent parts. Replace any damaged components. If steering wheel is off-center and rear toe is OK, go to step 7.
- Loosen the nuts and bolts on the Rear Suspension Arm No. 1 on both sides and jounce the vehicle.
  - If the rear toe alignment is within specification, tighten the nuts and bolts on the Rear Suspension Arm No. 1.
